MORTON THIOKOL INC.
Space Operations

**Assembly Test Article (ATA)
Final Test Report**

February 1988

DOC NO. TWR-16829	VOL
SEC	PAGE

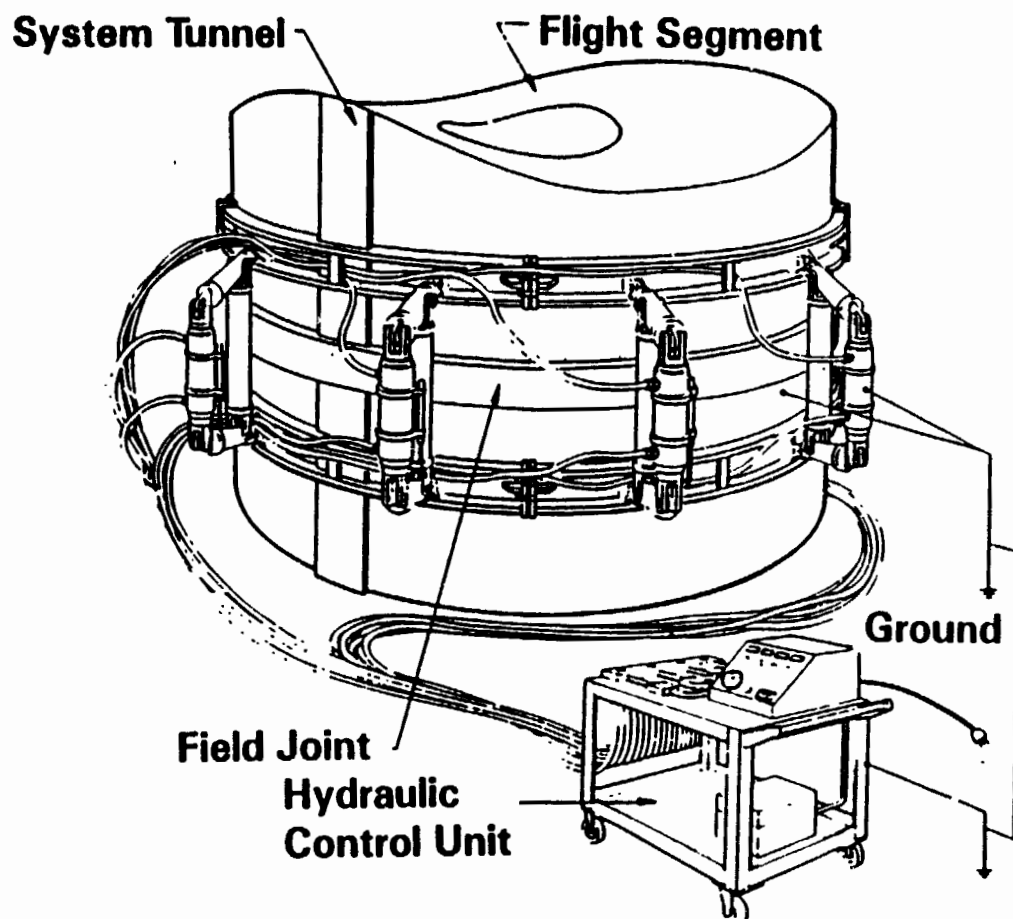
Figure 7-4. Vertical Separation Fixture (VSF)

- d. Vertical Separation Fixture (H77-0451)--This fixture was used to separate the segments after the dry mate. Separation was erratic and uneven primarily due to lack of operator training. Due to risk of segment damage, no joint separation should be attempted without the VSF. Improvements to the fixture are being made prior to use on any flight contingency destacking operation. With these changes, the 7U52818 VSF is certified for use on flight segments.

3.3.1.3 Vertical Separation Fixture (VSF). Additional training for the VSF operation is needed, as it is felt lack of operator training was the primary cause for the erratic separation during the first full (dry) mate. No segment separation or demate should be attempted without the use of the VSF to insure no damage to the segment. In addition to crew training, other recommended changes are:

- a. Hydraulic cart size reduction to improve work platform level accessibility.
- b. Hydraulic hose lengthening for operational ease.
- c. Main control valve sensitivity reduction, to reduce the chance of operator error.
- d. Elimination of the LVDTs on the VSF cylinders.
- e. The main pressure gage readout scale should be replaced with one that is scaled for easy readability in the sensitive operating range.

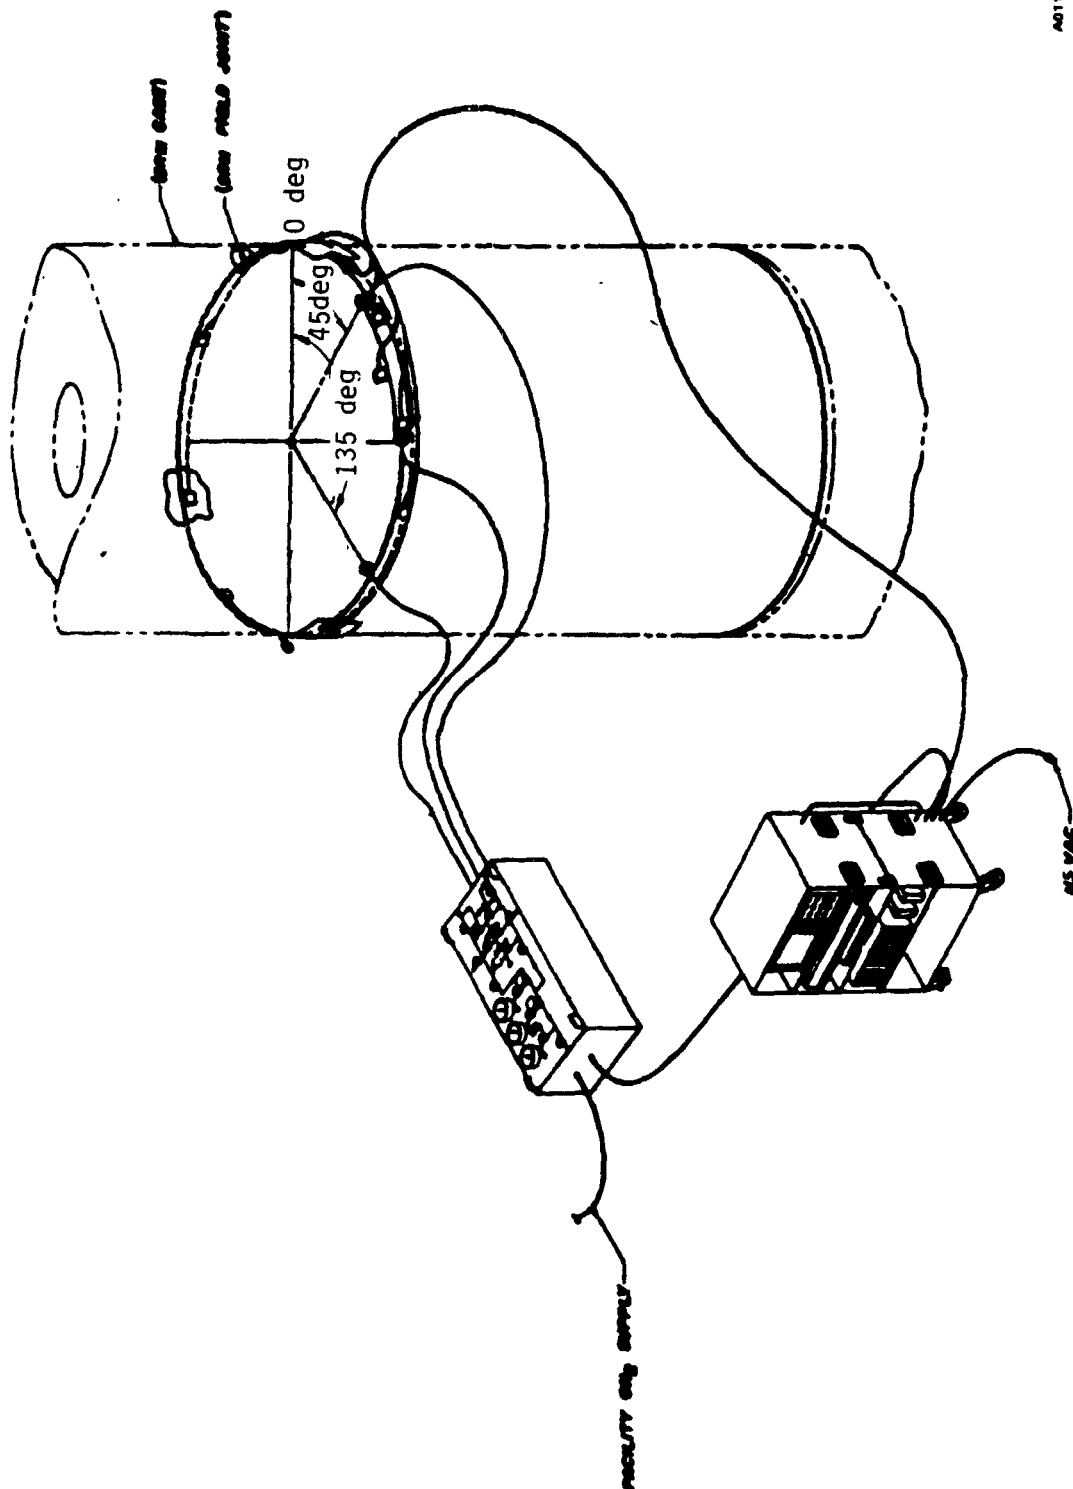
Figure 7-5. Joint Leak Check System

Due to this test (ATA) being the first use of the upgraded system (a prototype was used on the DM-8, DM-9, and JES-3B tests), some problems were naturally encountered with the hardware. The primary problem was valve sticking. The valves used on the equipment were custom made, and it was found that the operators would tighten them too much, causing the valve needle to bind. During the test, this was temporarily resolved by removing the handle and gently striking the valve with a soft hammer. This problem will be resolved by incorporation of a torque limiting ratchet type handle, that will free spin once the preset torque limit is reached. Also the surface finish of the port components were changed from 32 to 20, to reduce the possibility of sticking. Other improvements to the hardware under consideration include incorporation of convoluted flex lines to replace the currently used hard tubing (it was found common flex lines leak). Tests are currently being performed to ensure the convoluted flex line volumes do not change with pressurization, thus adversely effecting the leak rate calculations.

Some program software discrepancies were also determined. The software program contains over 8,800 lines of code, and no time had been available to completely debug the program prior to use up on the test level. There were no problems with data acquisition and recording (so no measurements repeats were necessary), but discrepancies were found in the data reduction. Some real number syntax errors were also found. These were subsequently corrected and the joint leak results were determined. Other software improvements being made deal with operator interaction. Before, sequence initiation and termination were driven by the computer clock. If the operators were not able to perform the right function in a specified time (such as opening or closing a valve), sequence continuation would still occur. Changes have been made so the operator starts and ends the various test sequences, allowing verification of proper equipment functionality prior to measurement. Updates are also being made to display measured values as they are acquired, allowing hand calculations during the procedure if desired. When the leak check process is complete, a final summary is printed for review.

- a. A torque limiting ratchet type valve handle will be used to avoid overtightening.
- b. Flex lines will replace the currently used hard tubing, if it is verified the flex line volumes do not change with pressurization (adversely affecting leak rate calculations).
- c. Software changes to allow the operator to start and end the various test sequences are being made, allowing verification of proper equipment functionality prior to measurement. Updates are also being made to display measured values as they are acquired, and when the leak check process is complete, a final summary will be printed for review.
- d. Additional procedural training in the leak check solution application technique, to avoid solution contamination and corrosion of the metal parts is needed.

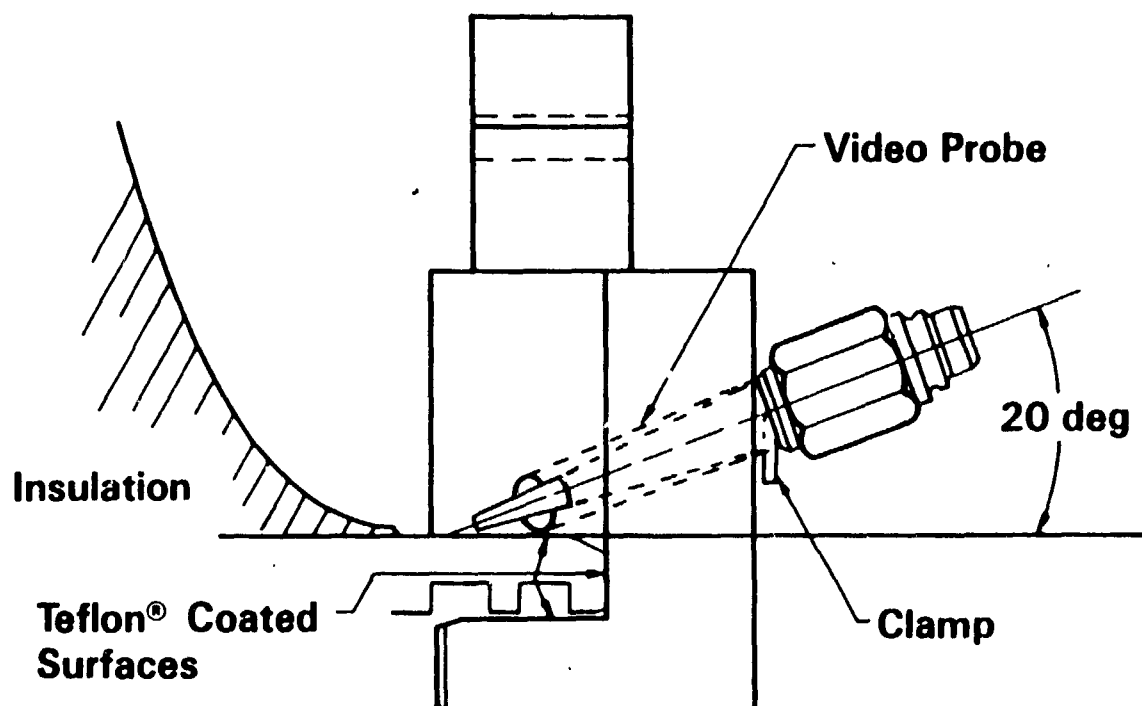
Figure 7-6. Mechanical Case-to-Insulation Bondline Inspection (air load on clevis end)

The operation procedure was altered slightly from that as originally intended. Instead of pushing the tool for a clockwise inspection, the tool operated more smoothly by pulling (counter clockwise). The speed of inspection varied from 100 sec/10 deg to 60 sec/10 deg. The video field of view was 0.718 inches. Unbonds were plainly detectable and visible. Inspection results indicate the air jet does not enlarge unbonds. If the air does cause a previously undetected unbond to open up, it is felt that good case bond was not present initially.

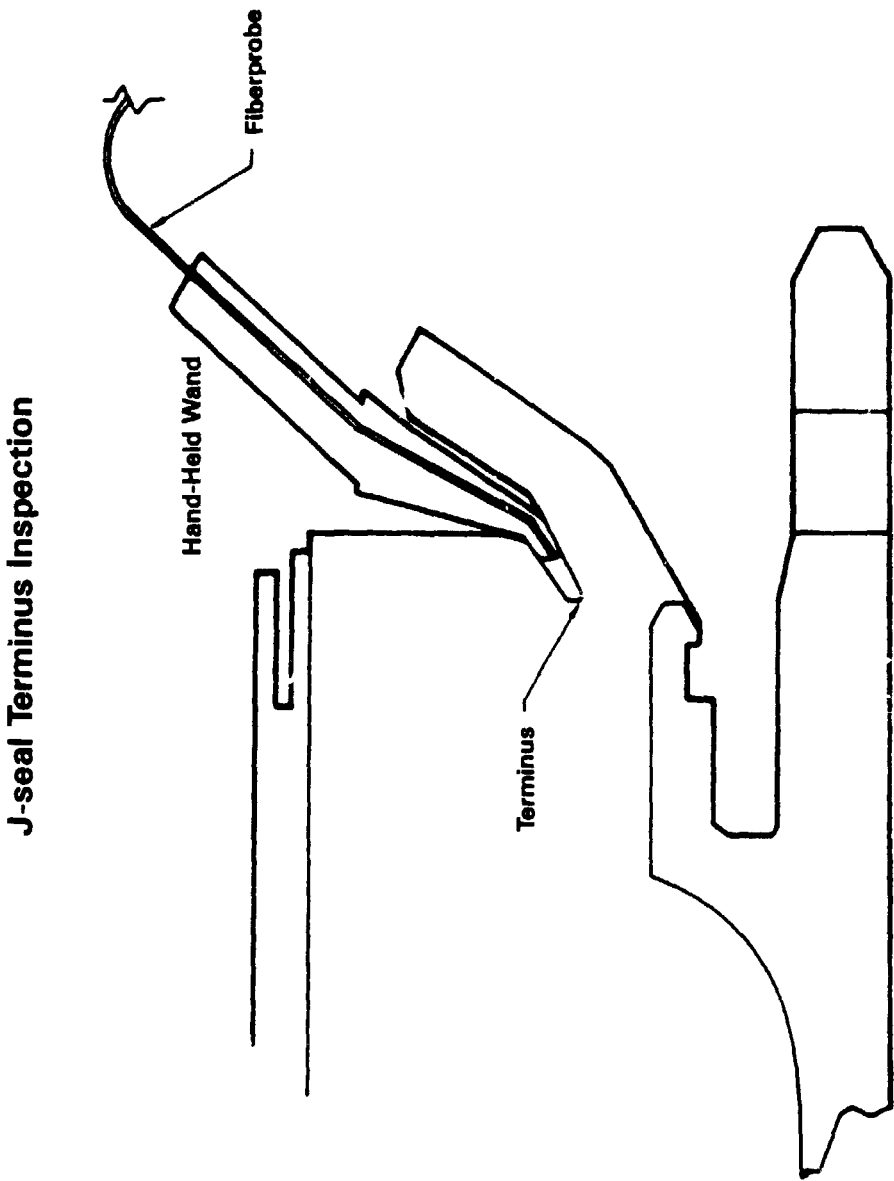
Figure 7-11. J-seal Terminus Inspection

A relatively large amount of dirt and/or dust was found in the terminus area. No abnormalities other than the above mentioned dirt and dust were found in the J-seal terminus area around the entire circumference. One suspect area was noted at approximately 57 deg, but was later determined to be some type of debris, either dirt or dust. Debris was also found to be concentrated around the rubber mold flashing approximately every 15 deg. This was to be expected and was not a cause for concern. No transportation or handling defects were found in the J-seal terminus area prior to joint mating.

A recommended improvement to this GSE equipment is a reduction of the current wand width. This would allow easier lateral movement within the J-seal, avoiding the need to remove the wand and reinsert it at the new measurement position. The fiber optic cable connection to the camera needs to be dead ended to prevent rotation, otherwise determining crack orientation is not possible. It is also recommended that offline computer enhancement and characterization be done to further evaluate future inspection results. If this cannot be done, a leader should be produced on the inspection tape to explain the images.

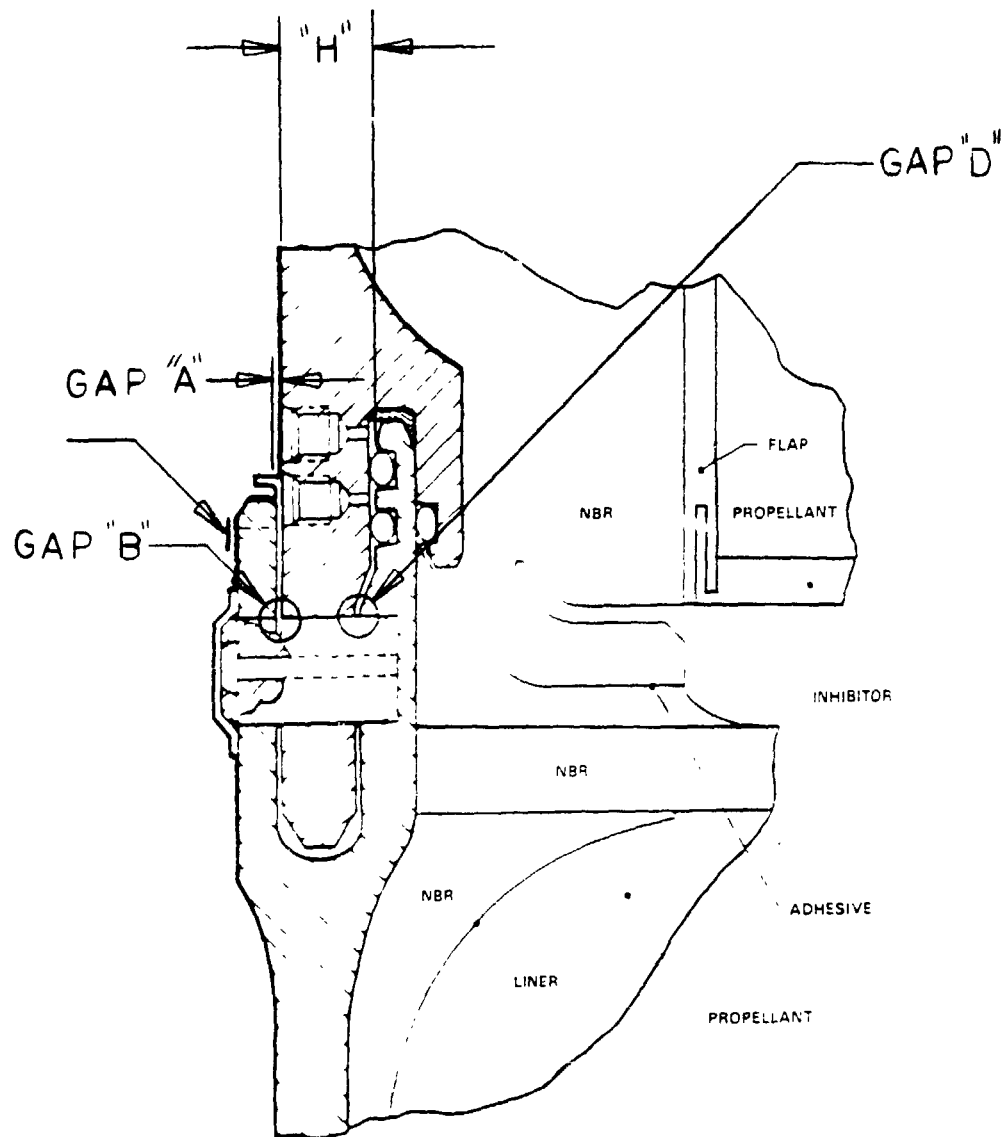
Figure 7-17. Assembled Joint Measurement Locations

The 45-deg port measurements show that the clevis gap opening when assembled was 0.830 in. which is less than the unassembled gap opening and that there is no clearance between the tang ID and the inner clevis diameter.

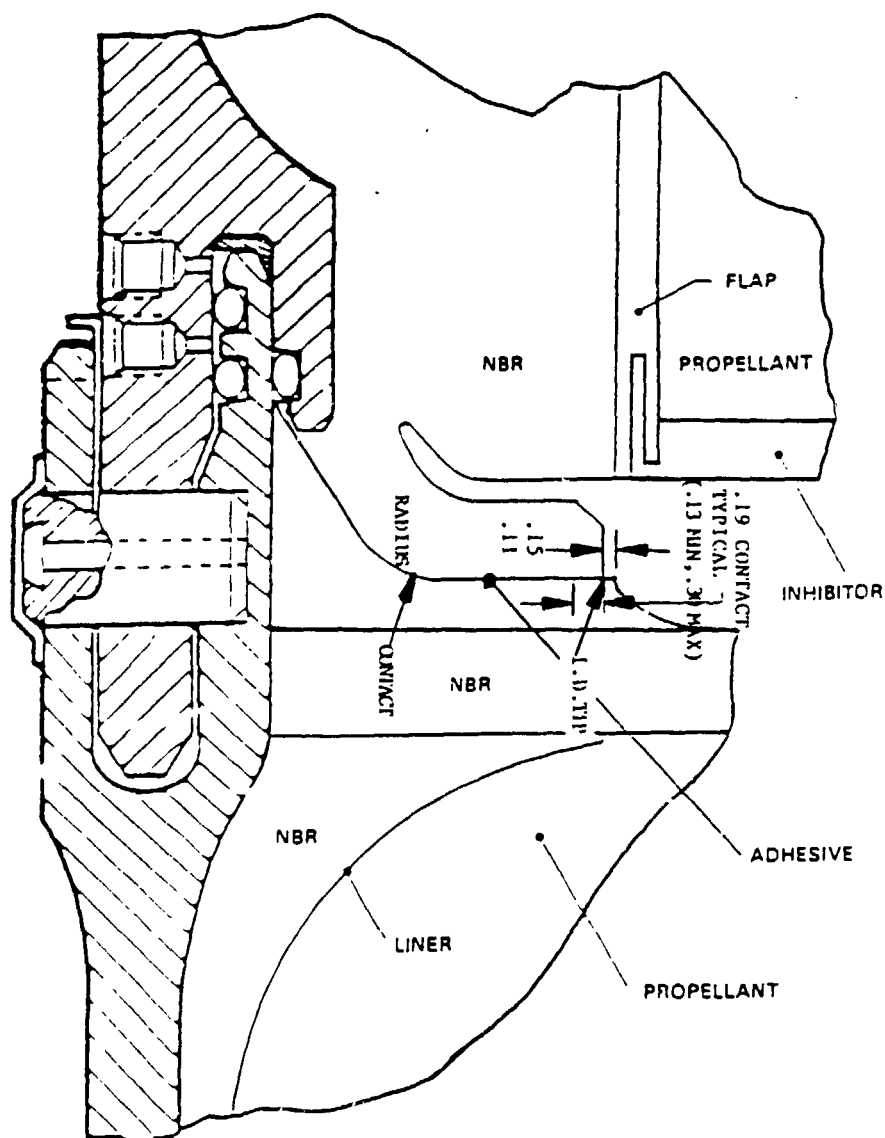
Figure 7-24. Wet Fit Inspection Summary

It is thought that the uniform band defines the original contact point on the clevis joint and the area scraped at assembly. The hairline
